## **09/22/81 Air Florida Airlines**

## Official Accident Report Index Page

Report Number	NTSB-AAR-82-3
Access Number	PB82-910403
Report Title	Air Florida Airlines, Inc., McDonnell-Douglas, Inc., DC-10-30CF, N101TV, Miami International Airport, Miami, Florida, September 22, 1981
Report Date	April 6, 1982
Organization Name	National Transportation Safety Board Bureau of Accident Investigation Washington, D.C. 20594
WUN	3492
Sponsor Name	NATIONAL TRANSPORTATION SAFETY BOARD Washington, D. C. 20594
Report Type	Aircraft Accident Report September 22, 1981
Distribution Status	This document is available to the public through the National Technical Information Service Springfield, Virginia 22161
Report Class	UNCLASSIFIED
Pg Class	UNCLASSIFIED
Pages	34
Keywords	rotor disk burst; uncontained engine failure; uncommanded retraction of the wing's outboard leading edge slat group; tensile type fractures; foreign material; 14 CFR 25, 33, and special conditions; rotor burst containment
Abstract	<p>About 1648 e.d.t., September 22, 1981, Air Florida Airlines, Flight 2198, a McDonnell-Douglas, Inc., DC-10-30CF sustained an uncontained failure of its right underwing engine (No. 3) during the takeoff

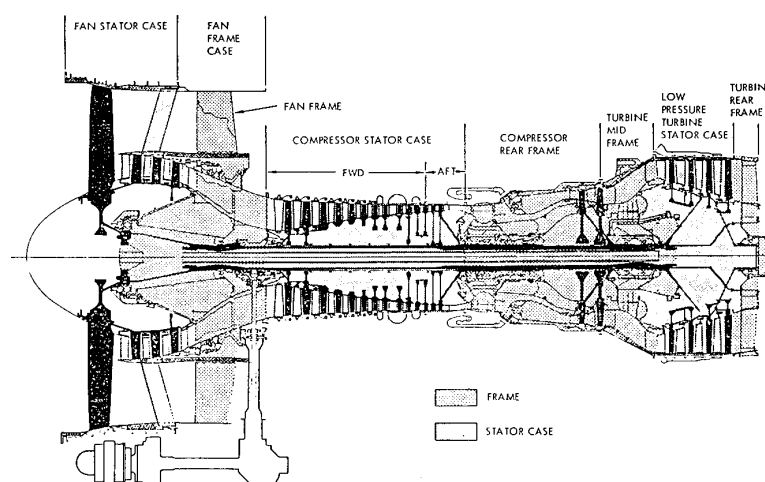
Figure 3.--CF6-50/-45 frames and stator assemblies.

The examination showed that the major damage to the engine was incurred aft of the high pressure turbine section. The low pressure turbine stator assembly case had separated circumferentially along the flange attaching its forward end to the turbine mid-frame housing. This separation, located at engine station (ES) 294, was just forward of the plane of rotation of the stage 1 low pressure turbine rotor. The stator case separated fore and aft along the top of the engine; it tore horizontally above its outboard split flange and the forward one-third of the inboard split flange had separated. The stator assembly case had split into three large segments and numerous smaller segments which separated from the engine and fell to the runway. (See figure 3.)

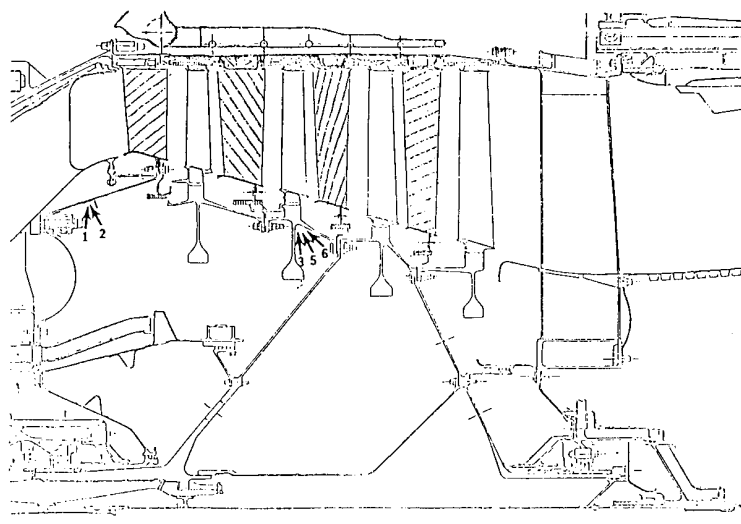
**Figure 4 Sketch of the low pressure turbine portion of CF6-50 engine S/N 455-123.**

Six additional pieces of ferro magnetic material were found: one piece was found on the runway; three pieces were found in the low pressure turbine stage 2 rotor cavity; and two pieces were found in the low pressure turbine's stage 1 toroid cavity. EDAX analysis identified the material as M-50 alloy steel. All six pieces were severely battered and oxidized. Five of the six pieces were measured for thickness. One piece was too battered for thickness determination. The thickness of one piece ranged from 0.140 to 0.150 inches; one piece was 0.148 inches thick; and three pieces were 0.149 inches thick. ([See figure 4.](#))

These six pieces were compared to a typical CF6-50 No. 5 roller bearing inner race which is manufactured from M-50 alloy steel. The specified thickness for this inner race is 0.146 inches to 0.148 inches. In addition, two of these six pieces had retained evidence of beveling and the geometry appeared similar to that of a typical No. 5 engine bearing inner race.

After the low pressure turbine failure of this engine, six pieces of foreign material were recovered and submitted for examination. For identification purposes these six pieces were arbitrarily assigned numbers - #1 thru #6. Pieces #1 and #2 were found near the turbine mid frame stiffener (see arrows #1 and #2). Pieces #3, #5, and #6 (see arrows #3, #5, and #6) were found in the cavity formed by the Stage 2 low pressure turbine disk and the forward low pressure turbine shaft. Piece #4 was recovered from the runway near the location where the engine failure occurred.
